HYUNDAI Technical Service Bulletin

Group	ENGINE
Number	09-EM-002
Date	MAY, 2009
Model	MULTIPLE MODELS (SEE BELOW)

Subject	CVVT OIL CONTROL VALVE INSPECTION
---------	--

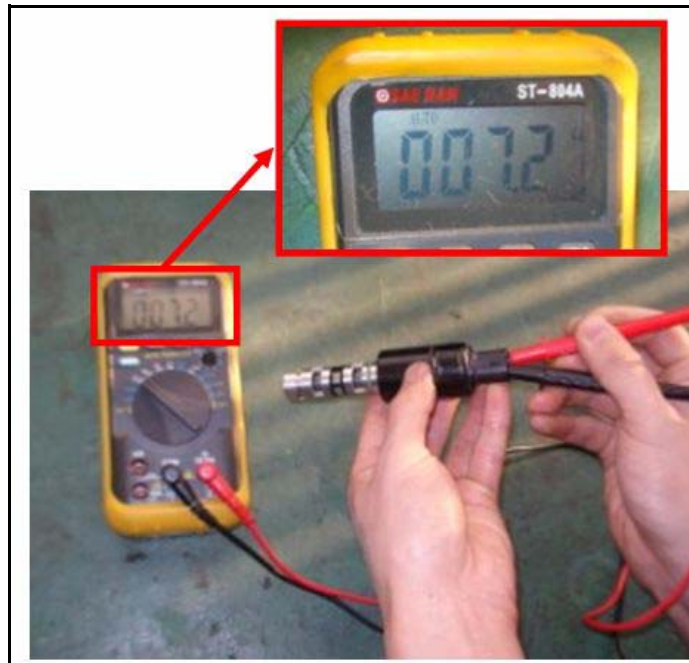
1. Measure the resistance between the OCV Power and Signal terminals.

MEASURED RESISTANCE 68°F (20°C)	RECOMMENDED ACTION
Denso (6.9~7.9 Ohms) Delphi (6.7~7.7 Ohms)	Check if the OCV operates normally by providing 12V power. (See the STEP 2.)
Infinity (OPEN)	Open circuit - Replace the OCV.
Below specified range or zero	Short circuit - Replace the OCV.

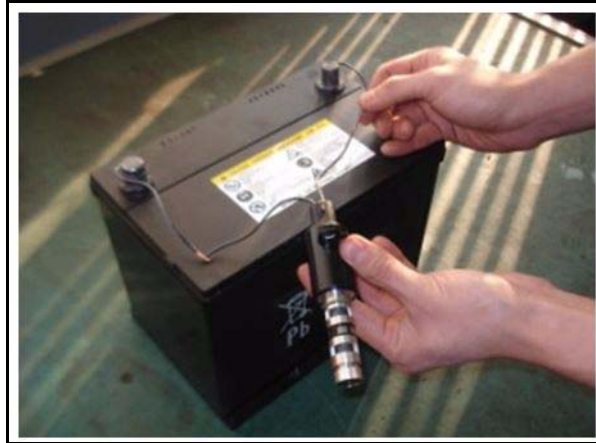
2. Check if the OCV operates normally by providing 12V power as shown in the picture below.

IMPORTANT: Careful attention is necessary to avoid a short circuit when providing the OCV with 12V power. Spacing between the OCV power and signal terminals is very narrow. Use suitable connections to prevent shorting of the test power supply.

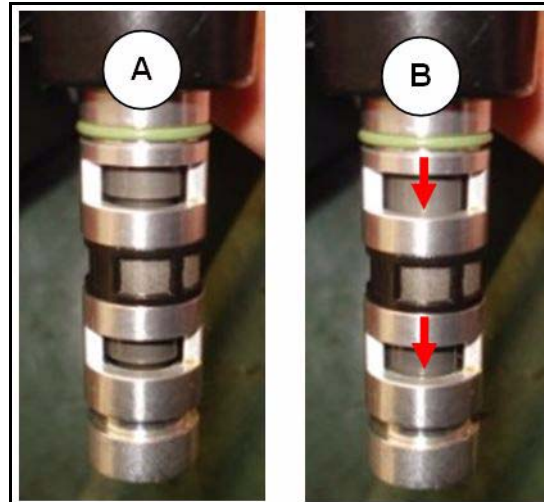
3. When 12V power is provided to the OCV, the OCV must move forward as shown in the picture to the right.

A: Maximum retarded valve timing condition (12V not provided)

B: Maximum advanced valve timing condition (12V provided)

NOTE: Reverse the connection polarity if the movement is opposite.

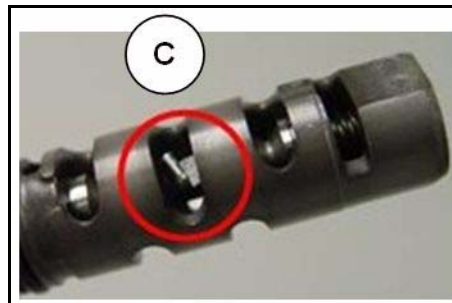
4. If the OCV does not move forward, examine if a foreign object like an aluminum chip (C) is jammed inside the OCV.

- Blow out the foreign object using compressed air, reinstall the OCV and then verify that the fault is corrected.
- If there is no damage to the OCV, then do not replace the OCV.
